## U.S. Department of Labor Mine Safety and Health Administration

## Fatalgrams and Fatal Reports

Fatality #9 - May 15, 2003 Machinery - NC - Granite (C&B) Martin Marietta Aggregates - Salisbury Shop

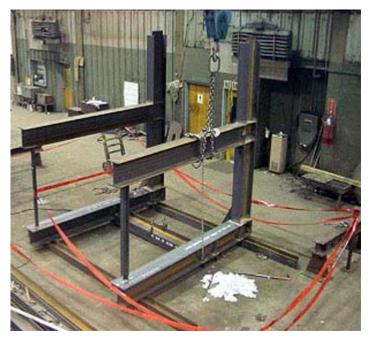
**METAL/NONMETAL MINE FATALITY** - On May 15, 2003, a 51-year-old master welder with 30 years mining experience was fatally injured in a shop at a surface stone mine. The victim was fabricating a screen tower section. Using an overhead bridge crane, he was positioning the 3-beam, right side component for assembly. While the victim was standing on the bottom beam, communicating with the crane operator and positioning a chain sling, the load shifted and fell, crushing him.

- Discuss work procedures and identify all hazards associated with the work to be performed along with the methods to protect personnel.
- Require all personnel to be positioned to prevent them from being exposed to any hazards.
- Never perform work on or have unstable structures/fabrications freestanding.
- Secure loads before unhooking them.
- Arrange the rigging to prevent shifting of the load being lifted. Balance the load by placing the crane or hook block directly above the load's center of gravity.
